## PD3/PD4 Upgrade Description—Network and RRS Registration

### **Problem: The Network and RRS Registration feature of PD4&PD3 is abnormal.**

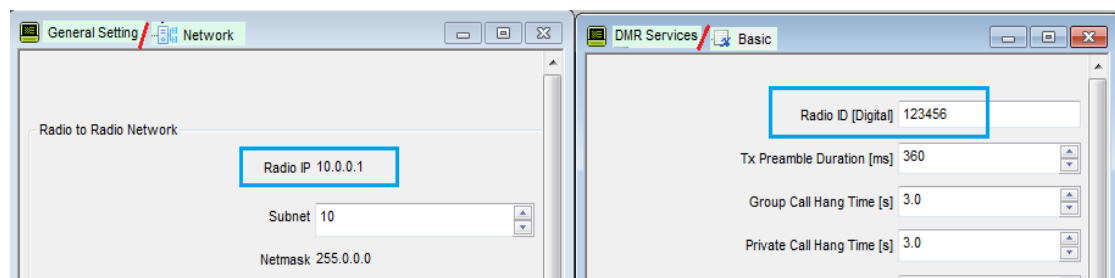
-----Figure 1-----

Radio ID on DMR Services/Basic is not associated with Radio IP on General Setting/Network, as shown in Figure 1.
